ERM-West, Inc., Torrance California

Decontamination of Styrene Manufacturing Plant

Client	Contact	Performance Period	Contract Value
ERM-West, Inc.	Alex Cates 925-946-0455	October, 2014 – March, 2015	\$5,342,095

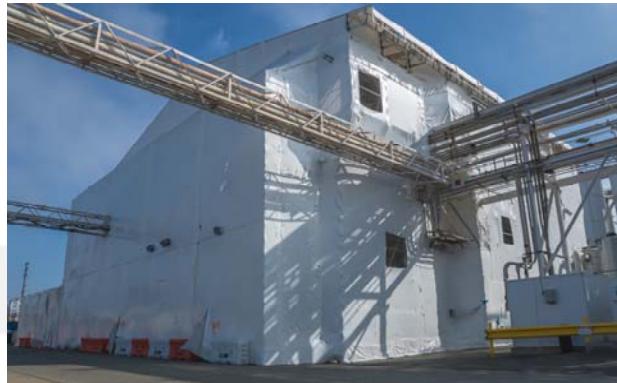
- ◆ Complete encapsulation of the processing train utilizing scaffolding systems, HAKI truss roofing and shrink-wrap methods of the exterior scaffolding.

- ◆ AIS established 24 hour negative air pressure within the containment. This was accomplished in two parts: first, utilizing a shrink wrap around the perimeter scaffold system and finally, by building of an additional interior containment to work within. This allowed a tunnel between the scaffolding and the work area to allow for full time air and visual monitoring of the interior containment. Negative air was established utilizing multiple negative air machines on each of the 4 floors throughout the train with HEPA Filters. Air exchanges were at a rate of every 7 minutes within the work area or 8 changes per hour.
